Soil Erosion And Causative Factors at Vandenberg Air Force Base, California

March 1988

Joel B. Butterworth
The Bionetics Corporation, Kennedy Space Center, Florida

John F. Kennedy Space Center

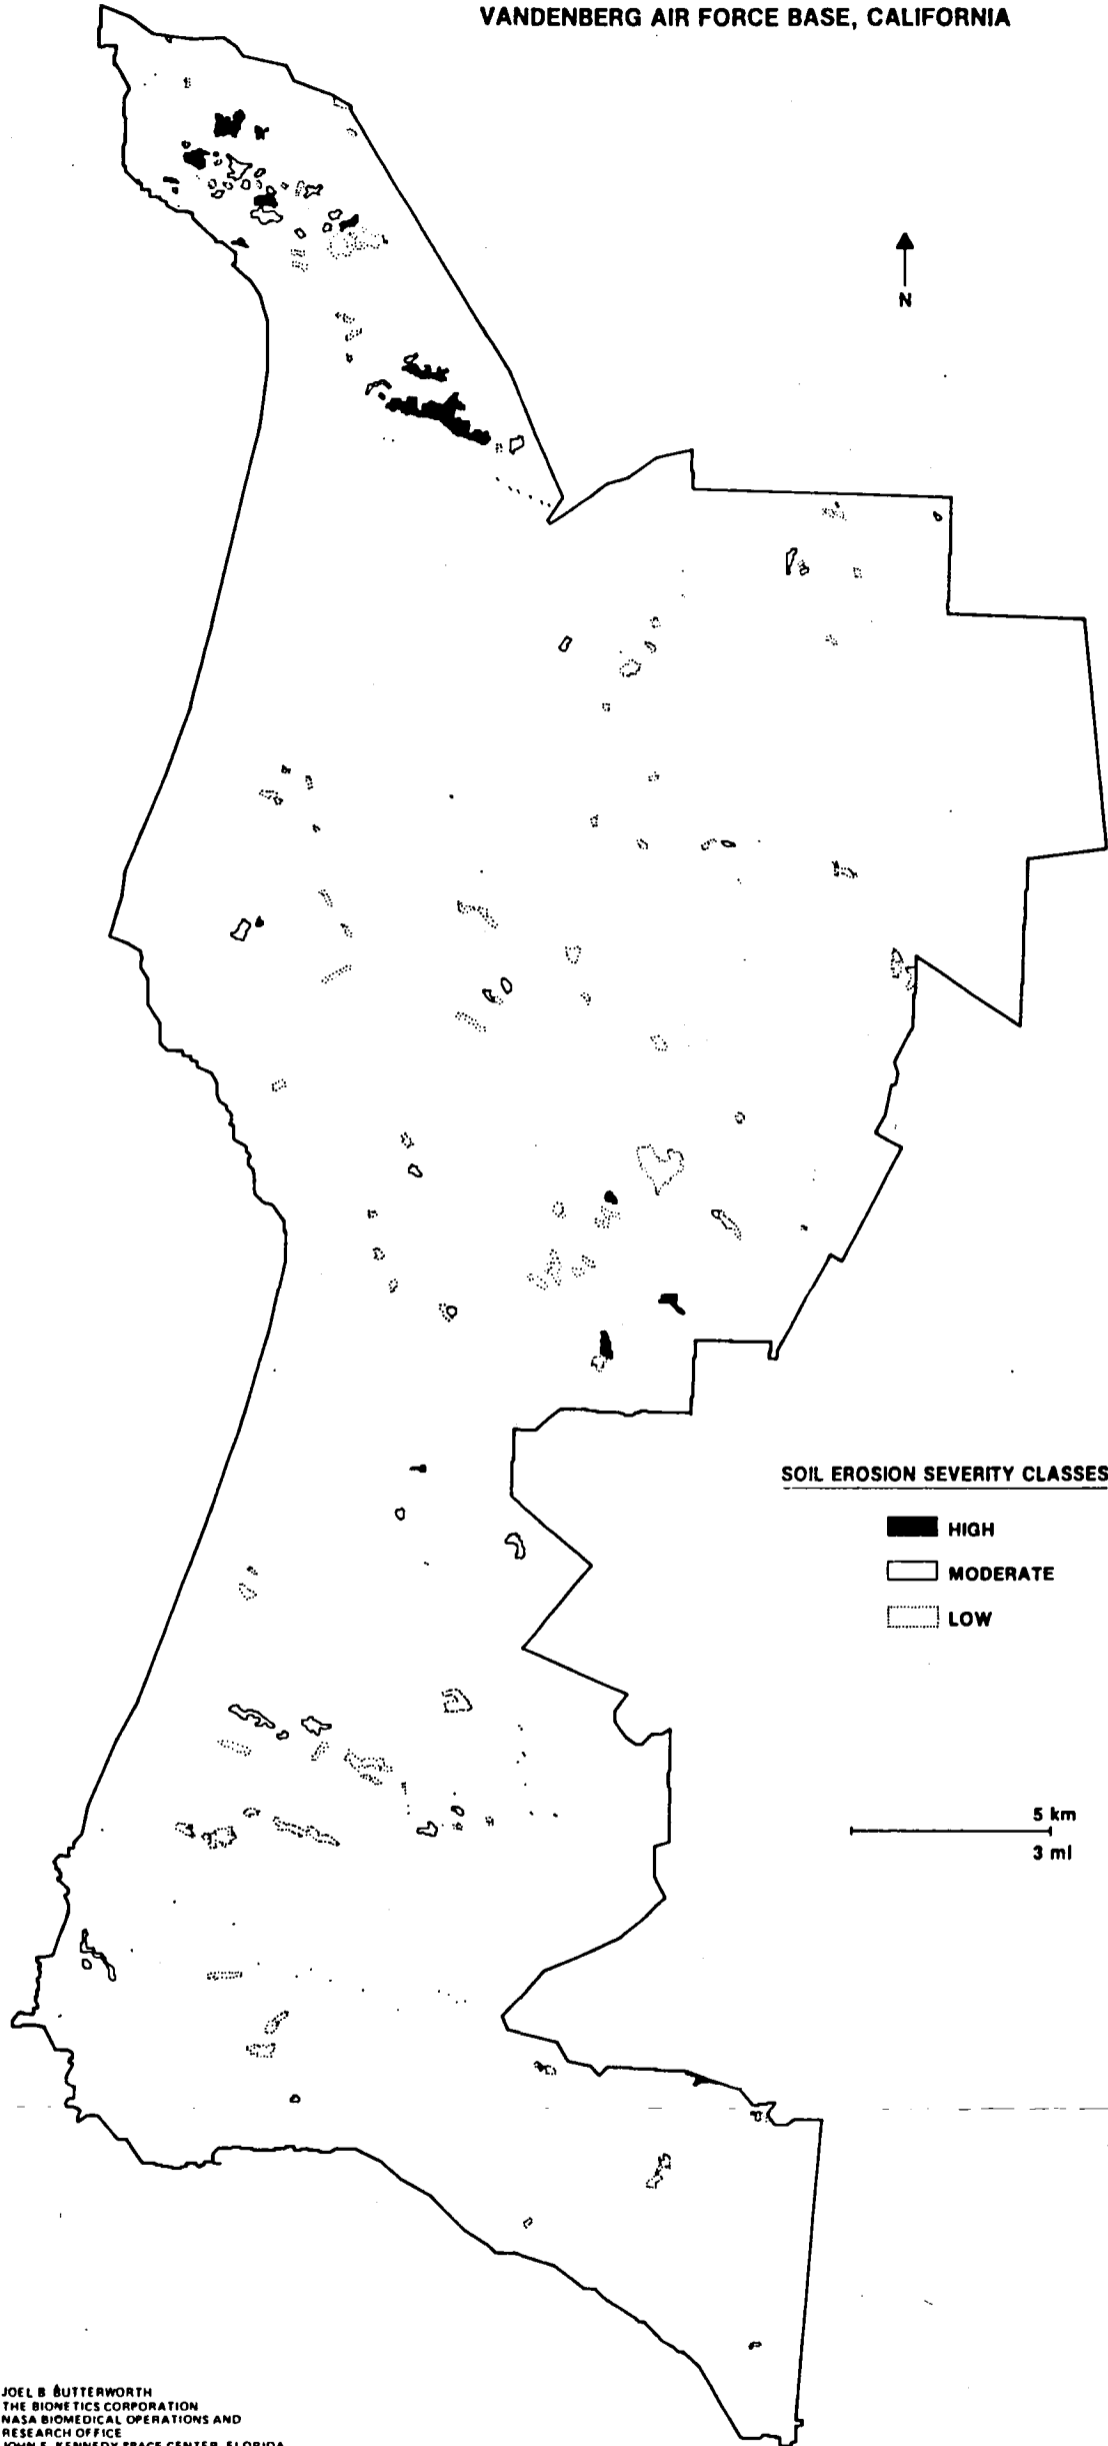
Figure 1. Map showing general distribution of eroded areas and unvegetated road cuts. Redrafted from composite ERDAS-generated map. See Butterworth (1987) for detailed maps.

One hundred ninety-three soil erosion sites were mapped; 142 were mapped as polygons, and 51 were mapped as point data (road cuts). The general distribution of these sites is shown in Figure 1.

A breakdown of erosion types according to severity rating is provided in Table 2. The majority of eroded areas and road cuts were classified as having a low severity rating. However, several of the sites classified as high severity are in obvious need of immediate rehabilitation; these particular sites are discussed in the following section.
